**Pavement Strength Analysis**  
**Prepared by Molzen Corbin**  
**September 2016**

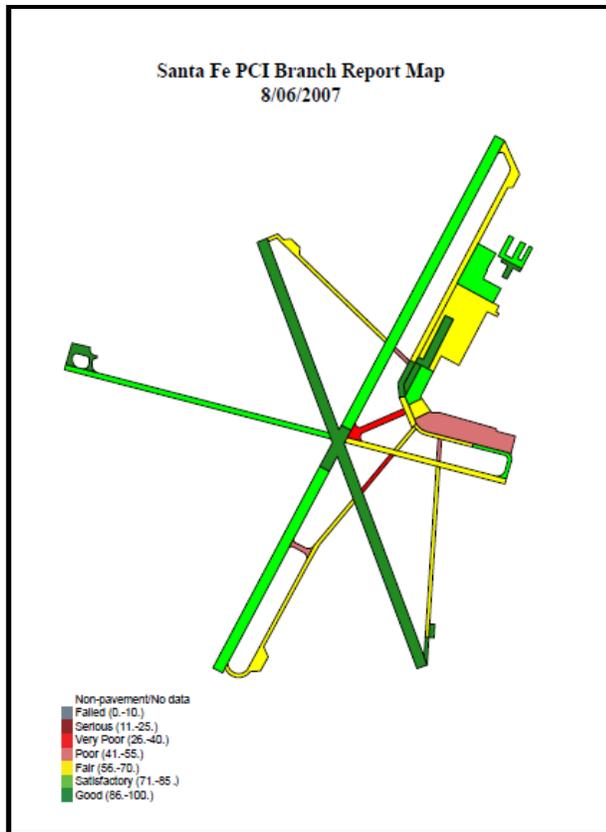
**Figure 1**  
**2007 PCI**

The true value of the PCI ratings is in the additional data points. Having one PCI on a pavement is helpful, but to have PCI values taken every five years or so is beneficial in seeing how the PCI degrades over time. Figures 1 and 2 show the 2007 and 2013 ratings.

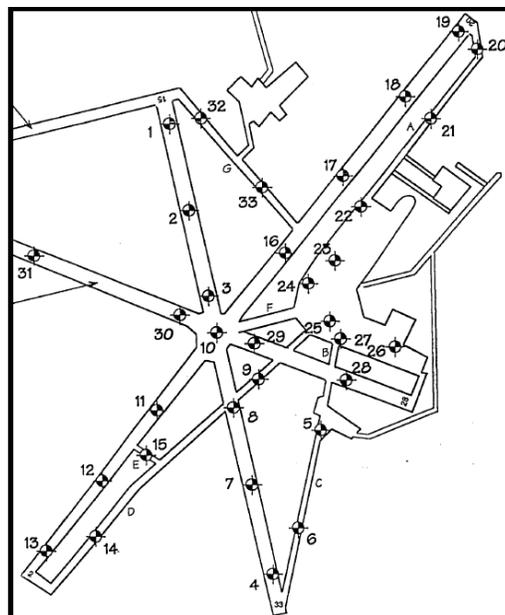
**Figure 3**

<b>Boring</b>	<b>Asphalt</b>	<b>Base</b>	<b>Classification</b>
13	6	8	Silty Sand, SM
12	4.5	7	Sandy Clay, SC
11	10	10	Sandy Clay, SC
10	12	10	Clayey Sand, SC
16	12	8	Clayey Sand, SC
17	11	8	Silty Sand, SM
18	10	8	Clayey Sand, SC
19	8	8	Clayey Sand, SC

The 1991 geotechnical investigation provided recommendations for pavement rating. The report stated, “The pavement strength evaluation would indicate the pavement to be capable of supporting dual wheeled aircraft over 110,000 lb except at Boring No. 12, where the pavement thickness and soil type indicated the maximum aircraft to be 65,000 lb.”

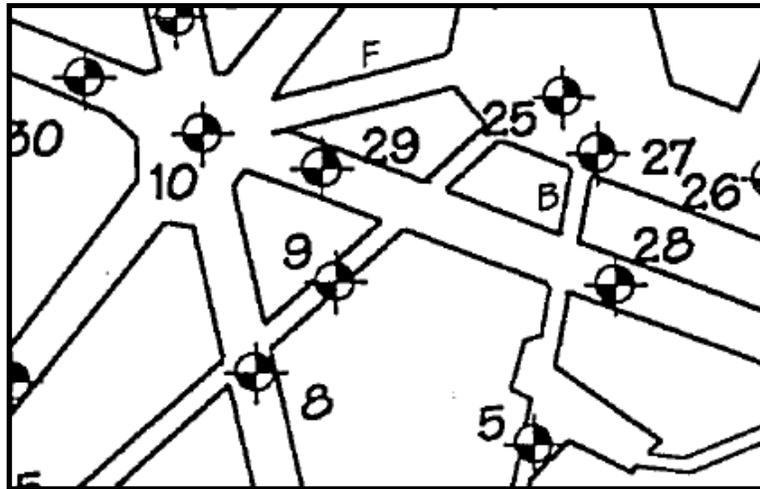
**Figure 4**  
**1991 Boring Report**

Boring 28 showed 3” of asphalt surface and 16” of aggregate base. Boring 29 showed 6.5” of asphalt surface and 8” of aggregate base. That is why this segment of pavement was left in place.

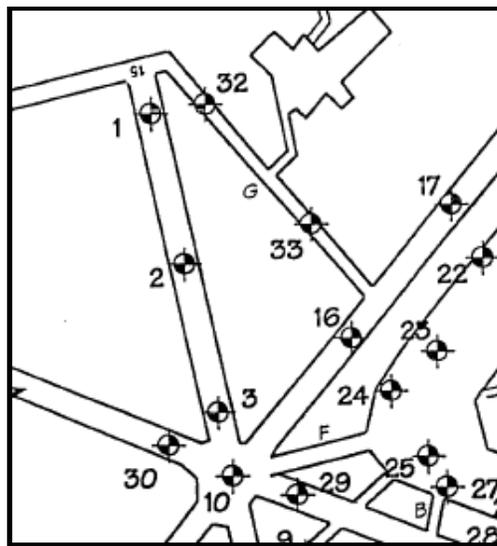
Figure 5  
Taxiway G Borings

Boring log 32 showed 6" of asphalt concrete, 8" of base course on top of Sandy Clay, CL subgrade. Boring log 33 showed 5" of asphalt concrete, 8" of base course on top of Clayey Sand, SC subgrade.

This taxiway is in need of total reconstruction and is on the airport ACIP in the near future. However, other projects have taken priority over this pavement for now.

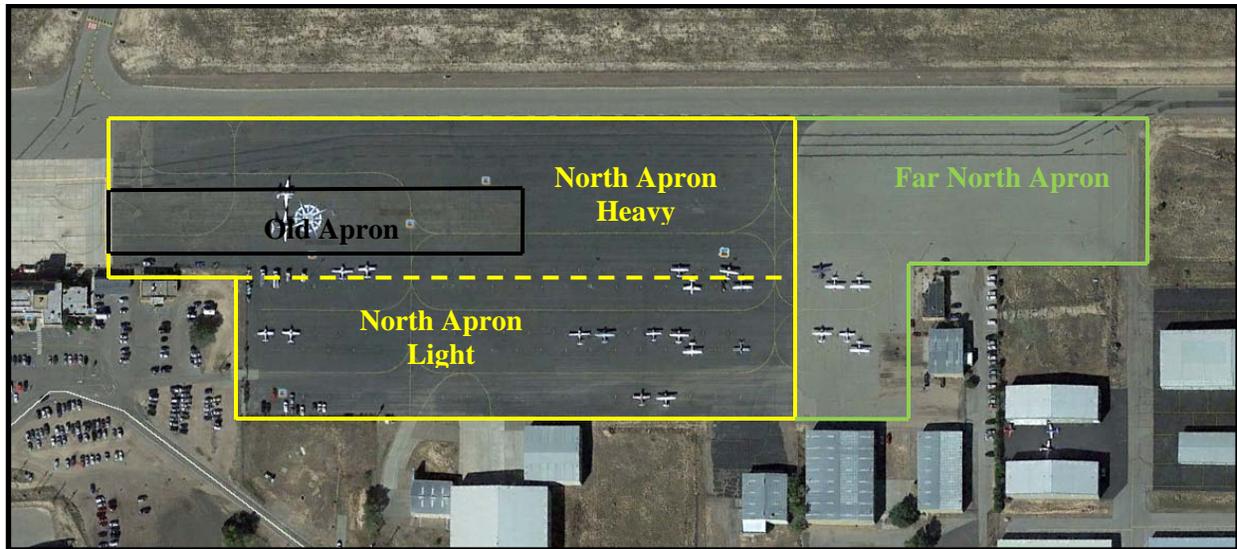
**Figure 6**  
**North Apron Sections**

Constructed in 1991, the 2007 PCI rating was 46-71. Amazingly, the portion of the north apron which was not touched (shown as “Old Apron” in the figure below), as it was the original construction, has a PCI rating of 86-100. The 2013 PCI rating was 44-46. While the PCI is low, the apron is performing well. There is cracking, but there are no subgrade failures, potholes, or other major concerns at this time.

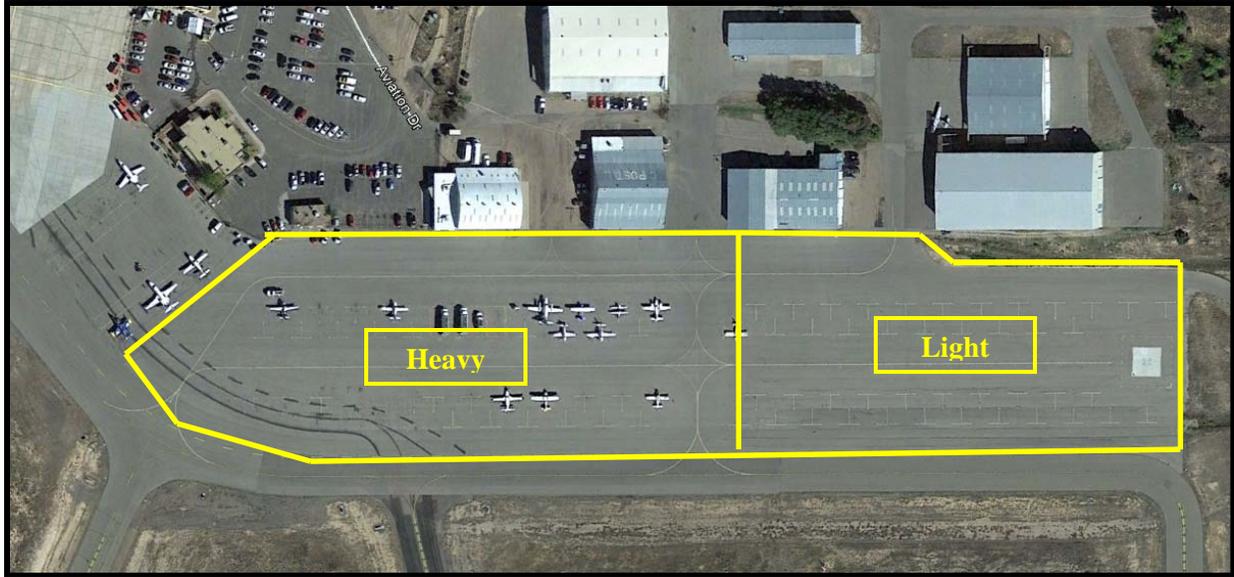
**Figure 7**  
**East Apron Sections**

It was constructed in two phases, under the same construction contract but with two phases of funding. It was completed in 2010. Some crack sealing has taken place on the eastern portions of this apron, but more is needed.

The 2007 PCI is not applicable. The 2013 PCI rating showed a PCI of 90 for the heavy section.

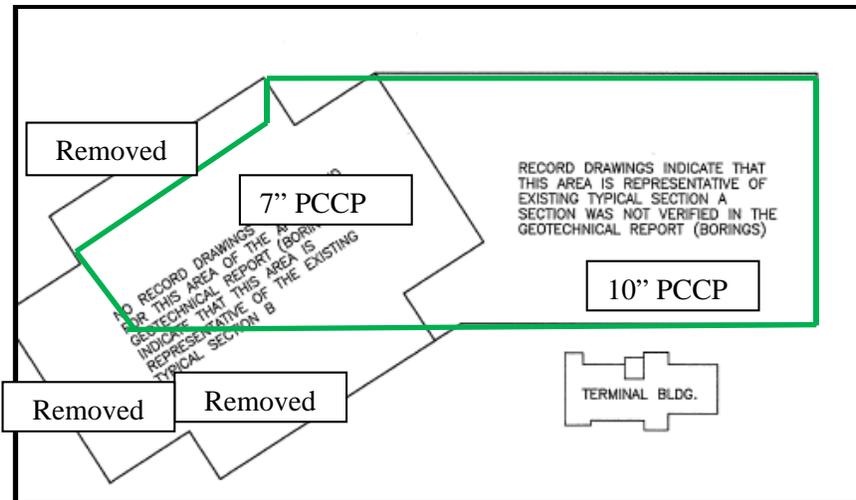
**Figure 8**  
**PCCP Thickness**

A project was completed in 1992 to remove and replace some concrete panels and to remove much of the eastern portion of the concrete ramp. Record drawings show that the concrete pavement was between 7" and 10" in thickness. A diagram from this 1992 project was included in the construction drawings and is represented in Figure 8 below. Typical Section A, as noted below, was the 10" concrete, and Typical Section B indicated only 7" of concrete pavement.

The green lines are the limits of the PCCP in place as of now.
